Water Quality Technical Report 2024-2025

March 31, 2025

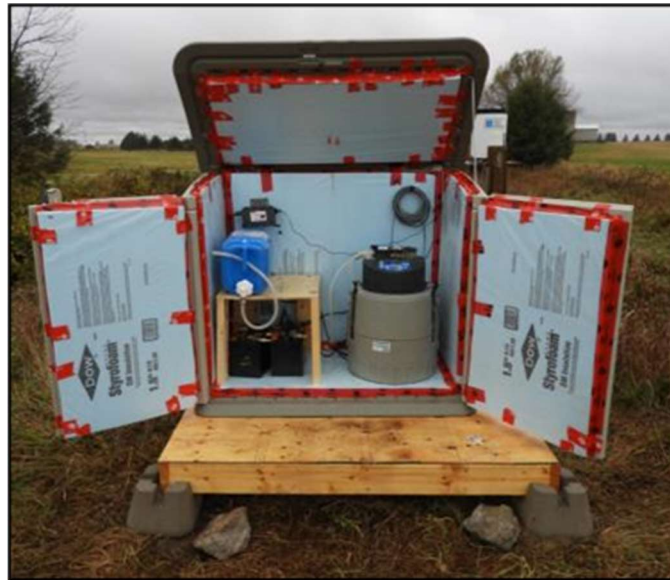
Figure 3. The inside of a water monitoring station established by the Upper Thames River Conservation Authority.

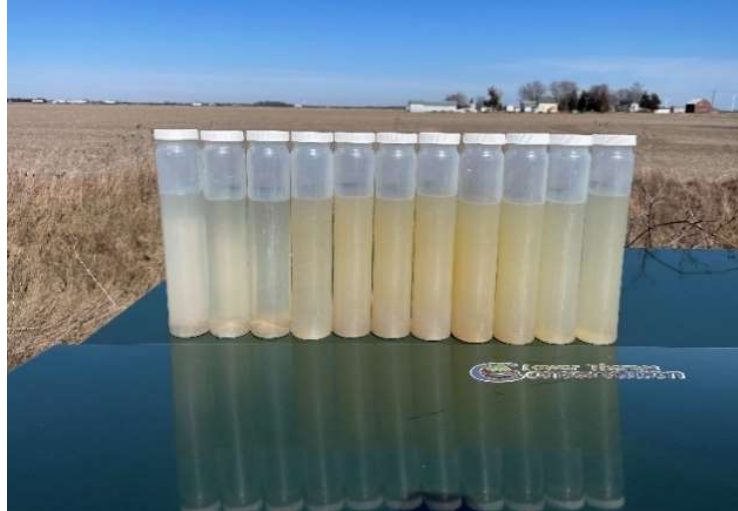
Figure 4. Visual assessment of variations in water quality following a sampling event, demonstrating baseline (left), rising flow (middle left), peak flow (middle), and descending limb of flow (right).

this equipment in place. Figure 4 shows the visual variation in water quality that occurs across a sampling event at Merlin B, as discharge increases to a peak in the middle of the event, coinciding with the highest turbidity in the samples.

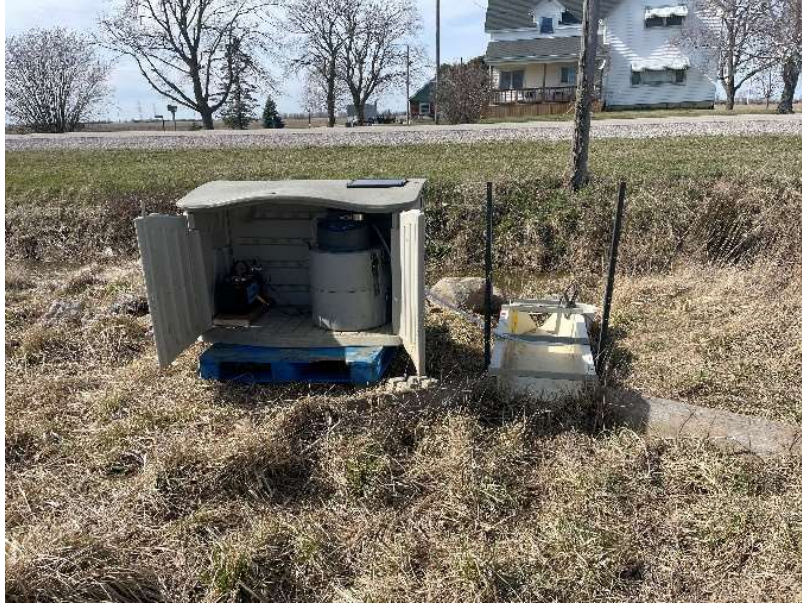
Figure 5. Merlin A's flume (right) capturing surface flow entering the municipal drain, with the permanent ISCO enclosure to the left.

Consistent monitoring set ups are used for each site (Figure 5). Each site contains two tile sampling locations, one flume for surface runoff, and one well depth monitoring site. There is some variation in the equipment used to measure depth, velocity, and flow (Table).

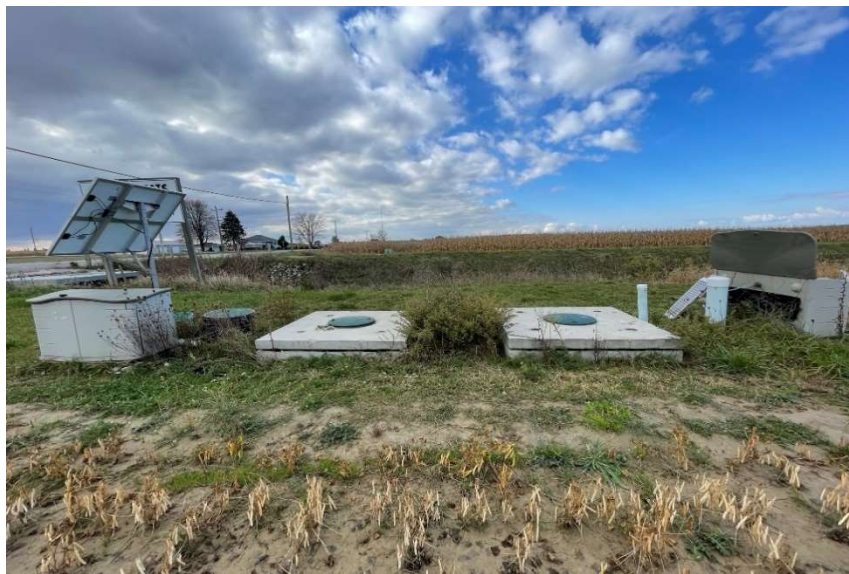
Figure 6. Fairview site containing an inflow permanent ISCO enclosure with solar panel [Right], first tank [Right Middle], second tank [Left Middle], and outflow permanent ISCO enclosure with solar panel [Left].

The Fairview site is located approximately 30 kilometers east of the Merlin A and B sites or 15 kilometers east of Chatham. The field is 100 acres, has high soil phosphorus levels, poorly drained soils, and drains into the Thames River. The Fairview site was previously used to test phosphorus absorbent materials and contains two tanks, and an inflow and outflow ISCOs (Figure 6).

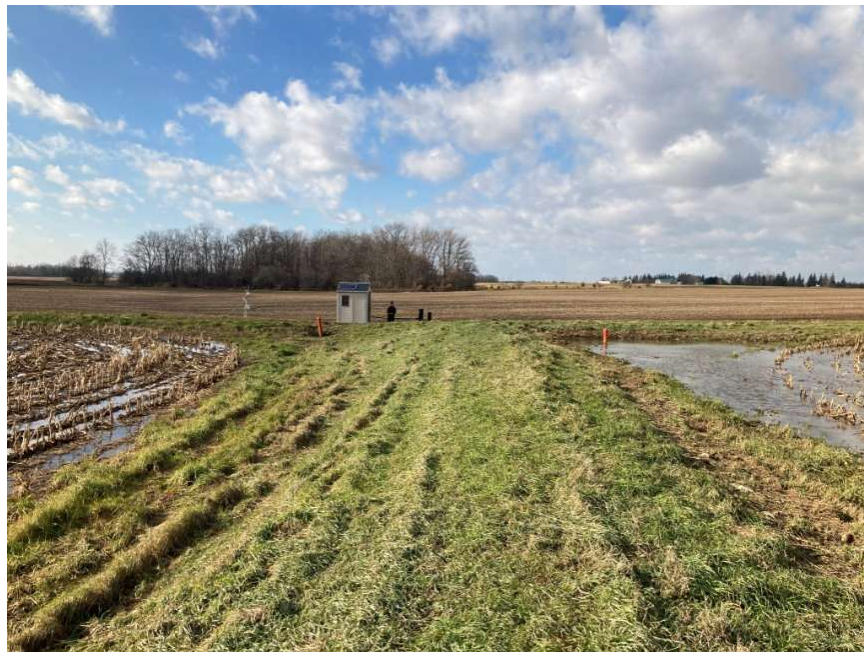
Figure 11. Photo of T-shaped berm separating the two monitored catchments at the North Kettle EOF.

In the North Kettle Creek subwatershed, an EOF station was constructed at a T-shaped berm that separates two distinct catchments in the field (Figure 10). Each side of the berm also has a separate surface inlet and tile outlet, allowing for different treatments to occur on either side. The North catchment serves as the experimental side, with a cover crop planted each fall, while the South catchment provides the control where no cover crop is planted (Figure 11).

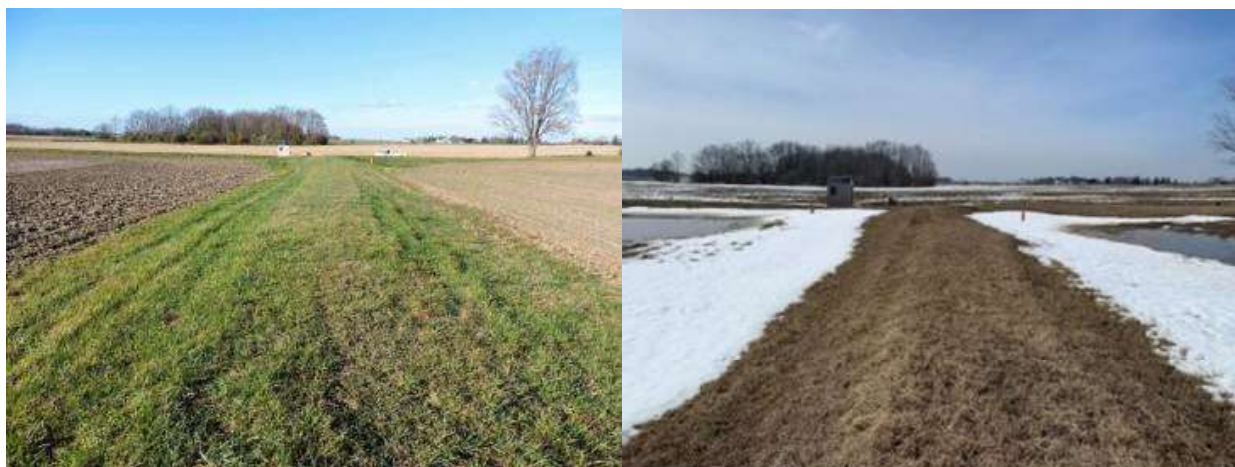
Figure 12. Poor establishment of a cover crop on the right field compared to soybean residue on the left field in November 2020 (left photo) and March 2021 (right) prior to a rain event.

Table 6 shows a breakdown of the timing, precipitation received, and runoff for five events, of which the last three occurred in March 2024 with a strong cover crop stand, and Table 7 shows water quality parameters calculated for the same events. The first, starting March 26, 2021, occurred when a cereal cover crop had been planted; however, the rye did not develop well and provided little more ground cover than the soybean residue in the control (Figure 12). This event provides a strong comparison as it occurred at the same time of year, and followed similar levels of snow melt through February. However, discharge levels were lower compared to the three events in 2024 (approximately half to four times less discharge occurred). The second event occurred Sept 21, 2021, when both sides of the field still had a standing crop of sweet corn present. This September event is unique in having the largest volume of discharge to leave either side of the field of all five events (an immense storm followed a long dry period), and for having a large amount of living biomass on both sides, shown in Figure 13. Hydrographs generated for each field (Figure 14) show how tile flow quickly reached maximum capacity, i.e. the periods of flat horizontal lines, for which continued for several days and led to surface water ponding near the tile inlet.

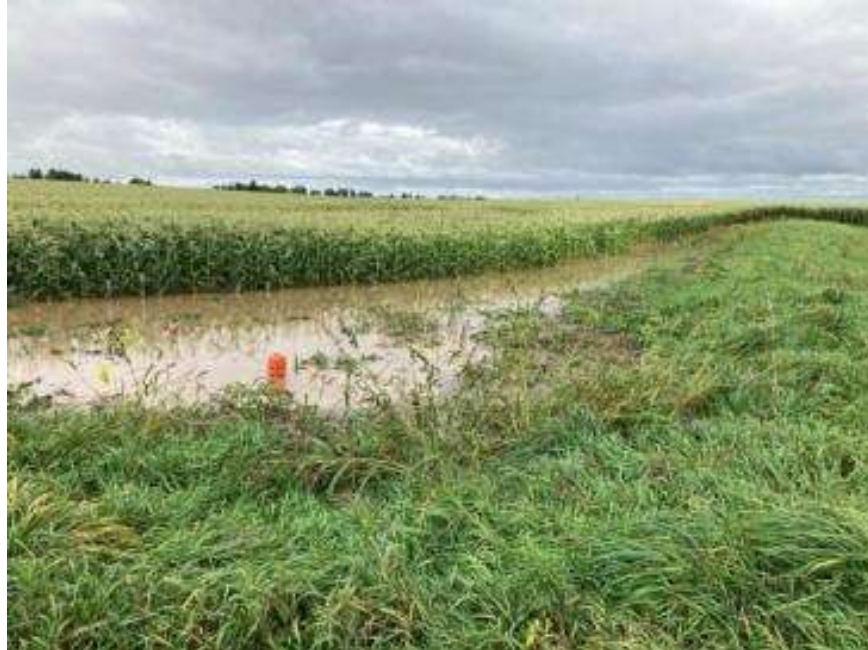
Figure 73. A rain event occurring in September 2021 on growing sweetcorn. The high precipitation led to standing water in field, and the highest level of discharge from the five selected events.

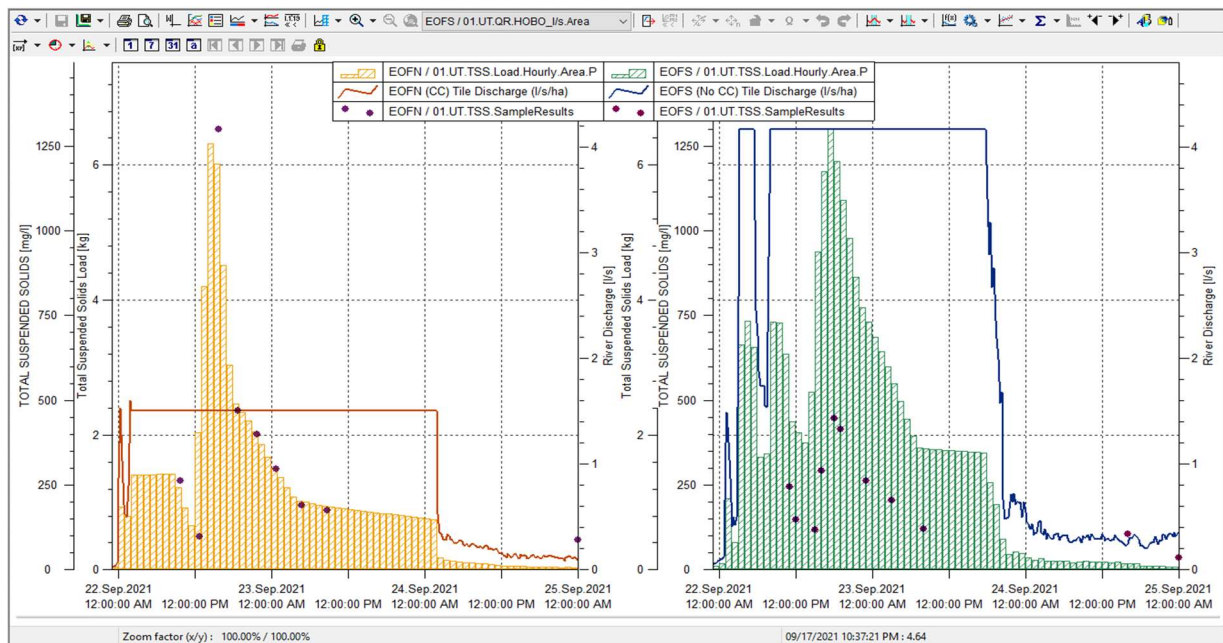
Figure 14. Hydrographs from the Sept 2021 event showing the responses in both sides of the field for water discharge (line), measured TSS concentrations (dots), and calculated TSS load (bars).

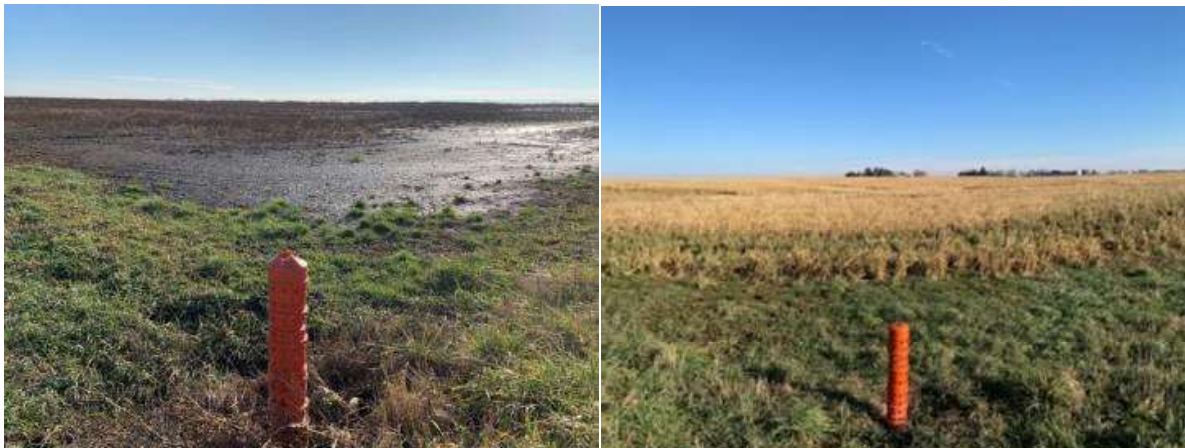
Figure 15. Photos taken in January of 2024 showing conditions on the no-cover field (left) and oat cover crop (right) prior to the series of rain events that would occur in March 2024.

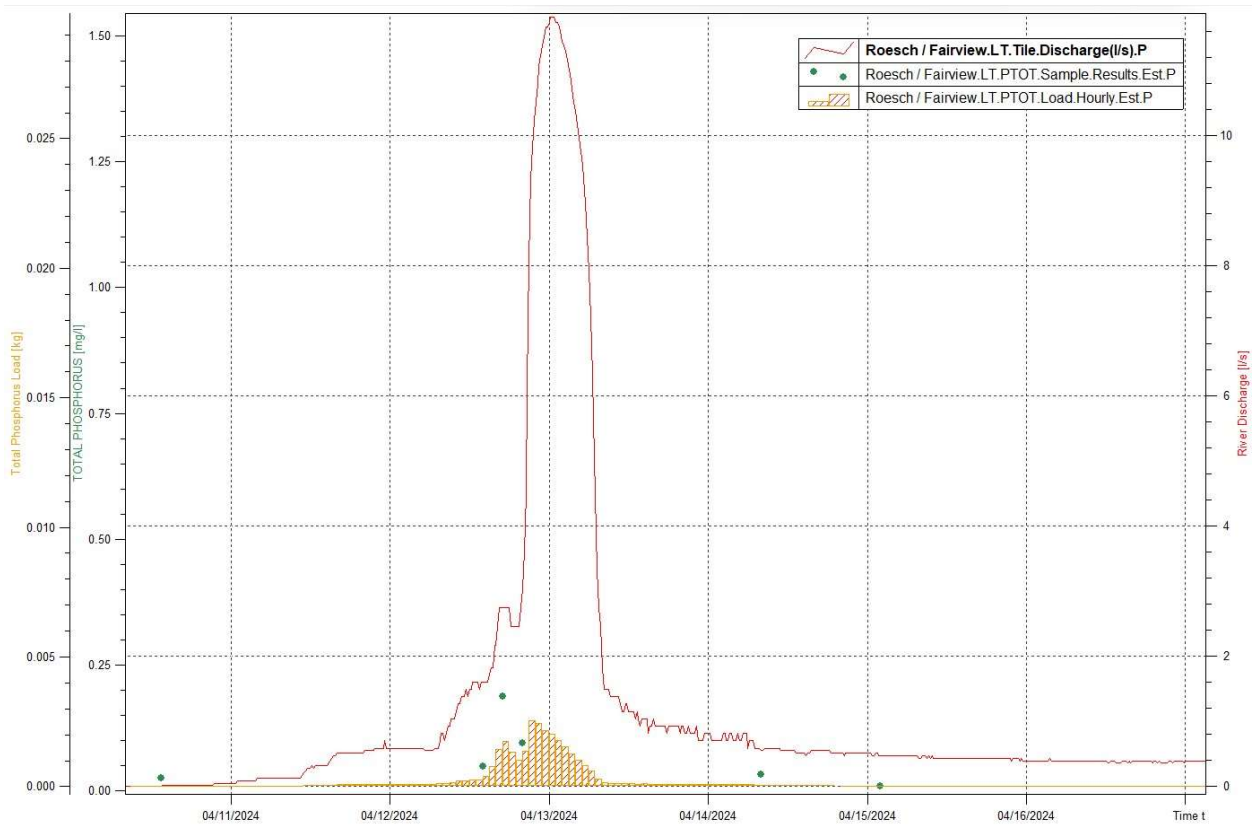
Figure 82. Tile discharge, measured total phosphorus (TP) concentrations, and calculated TP loads from Fairview's tile April 2024.

It is notable that of the four events detailed in Table 11, the pre-app event in April had the greatest amount of discharge at 715,000 L, while the first event after application had the lowest at 201,000 L. Not unexpectedly, the greatest amount of discharge did not lead to the highest losses of phosphorus and suspended sediment (TP shown in Figure 22), which occurred during the events after the application (TP from June 26 shown in Figure 23). It is clear from the second and third events that the impact of nutrient application lead to an increase in loads, even with the implementation of incorporation as a BMP. The biggest impacts were on TSS and TP, driven mostly by the increase in PP rather than DRP. Both TSS and TP had their greatest losses during the third event; confirming the impact of fertilizer application was not immediately dismissed by the first flush, and has the potential to be long lasting. However, this may be related to the size of the second event being quite small in comparison to events one and three and therefore not substantial enough to move the nutrients that were available. By the third event in August, nutrient loads were lower across all parameters even compared to the first pre-application event, confirming the application of nutrients would not continue affecting loads longer into the growing season.

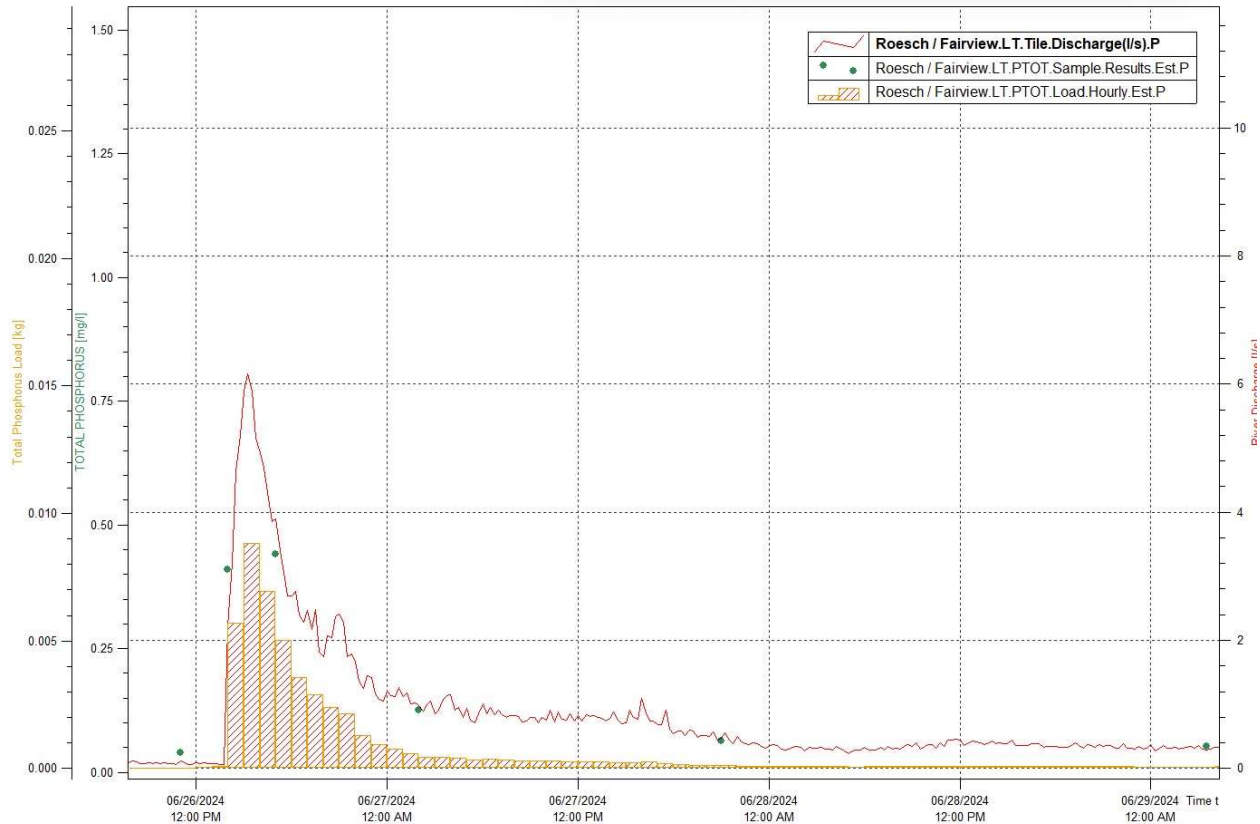
Figure 93. Tile discharge, measured total phosphorus (TP) concentrations, and calculated TP loads from Fairview's tile June 2024.

The loss of phosphorus being driven more by particulates than the dissolved reactive fraction combined with high losses of TSS suggest that loading may have been driven by other field conditions at this time. The limited increase in DRP at the second event is not unexpected; there was no phosphorus included in the fertilizer and much of the phosphorus applied in manure would have been held in the organic fraction. Instead, it appears sediment losses may have increased from the soil disturbance of incorporating the fertilizer and the minimal ground cover provided by the young beans which struggled to establish in with spring ponding occurring. However, this is not to suggest that incorporating was the wrong management choice – it is far more likely that nutrient losses would have been greater that way, an example of this impact can be seen in the 2022 ONFARM Water Quality Technical Report from monitoring at the retired Garvey Glenn EOF site when manure was spread shortly before a rain event.
